Q Inside Safety Technology

The Safety of Your Patients is Our Priority

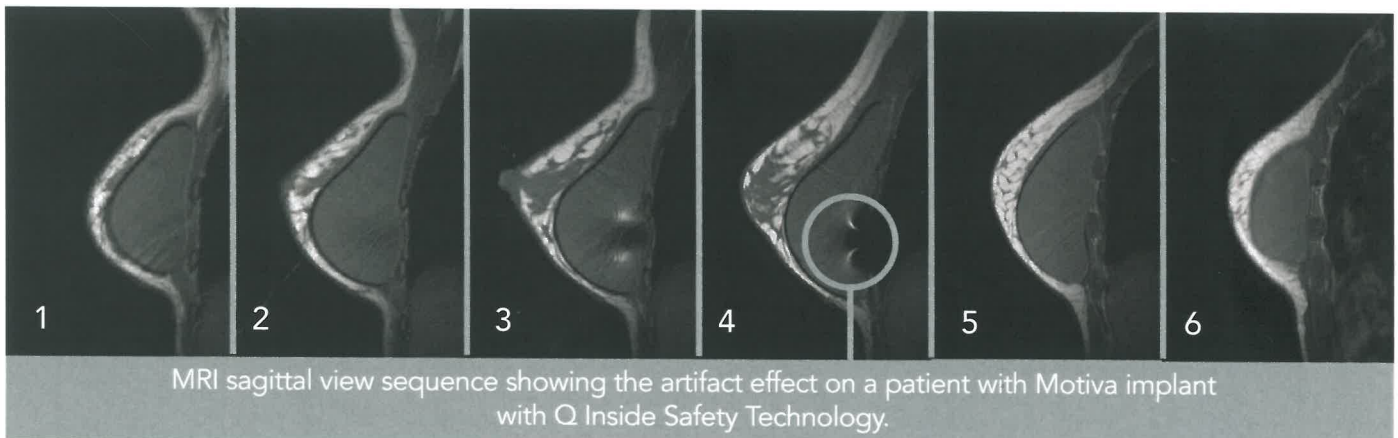
(Artifact only present in images 3 & 4, imaging technician able to obtain clear view in images 1, 2, 5 & 6)

Artifacts and MRI

- An artifact is a feature appearing in the MRI image that distorts the look of the tissue or organ being screened.
- Artifacts appear as shadows, distortions, halos, or create voids in the image.
- Artifacts cause misrepresentation of tissue structures.
